Contract #: 04-0120F4Cty: SF/ALA Rte: 80 PM: 13.2/13.9File #: 69.28**WELDING INSPECTION REPORT****Resident Engineer:**Pursell, Gary**Address:** 333 Burma Road**City:** Oakland, CA 94607**Report No:** WIR-011511**Date Inspected:** 07-Jan-2010**Project Name:** SAS Superstructure**OSM Arrival Time:** 645**Prime Contractor:** American Bridge/Fluor Enterprises, a JV**OSM Departure Time:** 1900**Contractor:** Zhenhua Port Machinery Company, Ltd (ZPMC), Changxing Island **Location:** Shanghai, China

Summary of Items Observed:

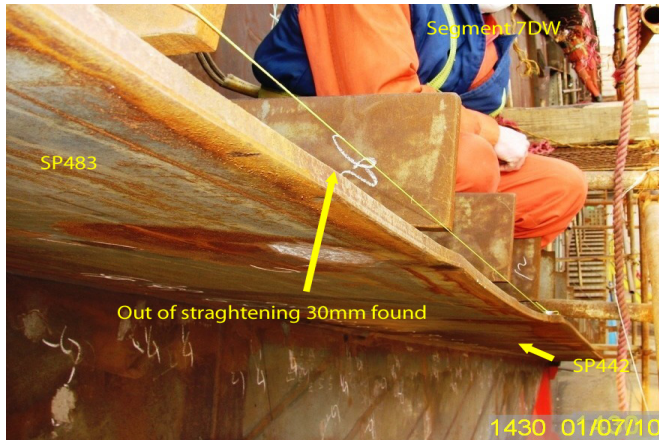
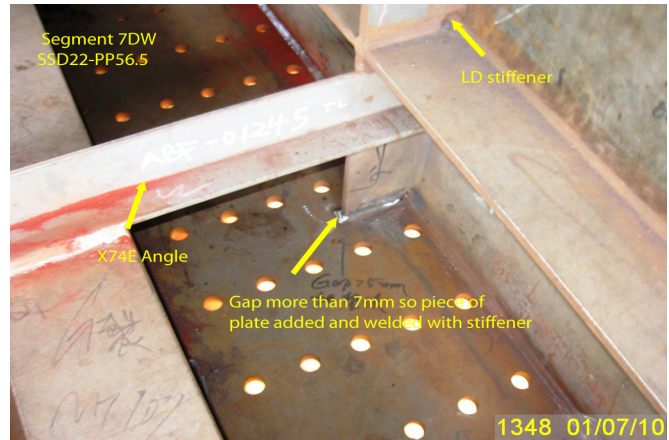
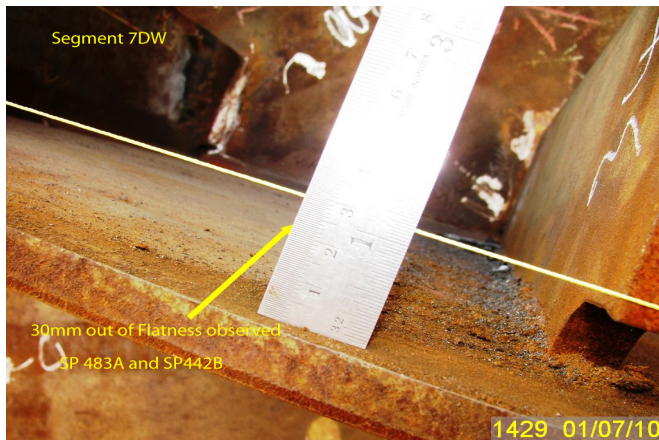
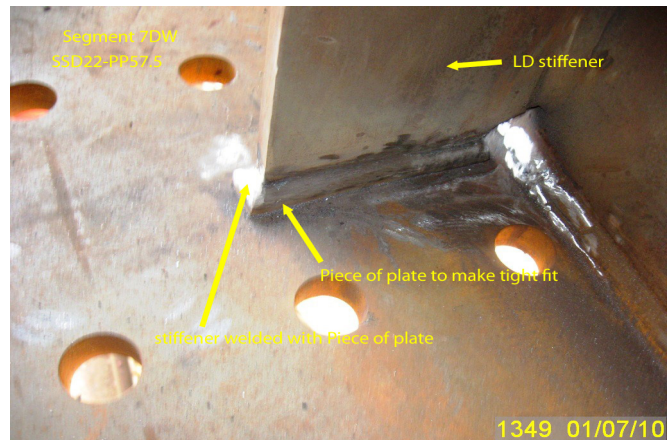
Segment 7DW Additional welding added the location where tight fit required is X74E Angle connecting longitudinal diaphragm in the bottom plate the weld location is identified as SSD22-PP56.5 to W4 And SSD22-PP57.5 to W4. The gap found more than 7mm instead of tight fit on that location so ZPMC put some small piece of plate on that location and done welding with stiffener to small piece of plate. Informed to ZPM QC Mr. Wang xian pin. See attached photos.

Segment 7DW Distortion found at the location of Side plate connecting to side plate , the plate is identified as SP483A to SP442B and the weld no is identified as SEG039A-024,25. So dimension measured with Caltrans

inspector Mr.Manikanadan 30mm max out of straightness observed and recorded sent to Engineer for further action. Informed to ZPMC QA Mr.Zhang wei.
